Rugby Borough Council Local Plan: Heritage Asset Review

**JS Conservation Management
& Town Planning Ltd**

September 2016

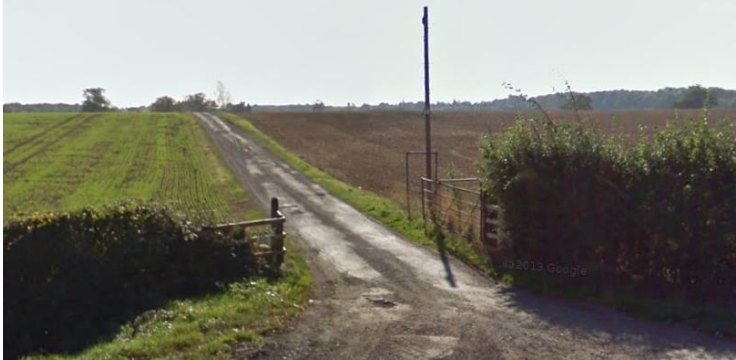
Asset Name	Grade	Photo
Coombe Abbey Registered Park & Garden (Oak Tree Avenue)	II*

- **Aesthetic Value:** Much of the aesthetic value of the tree-lined avenue has been lost due to the felling of the trees along the track. All that remains is the layout of the track which has aesthetic value in the relationship and interpretation of the estate in the 17th Century.
- **Communal Value:** Given that the avenue in the past will have been frequented by important people visiting the estate, the avenues do maintain a communal significance, as well as its attribution to William Winde's laying out of formal gardens and avenues.

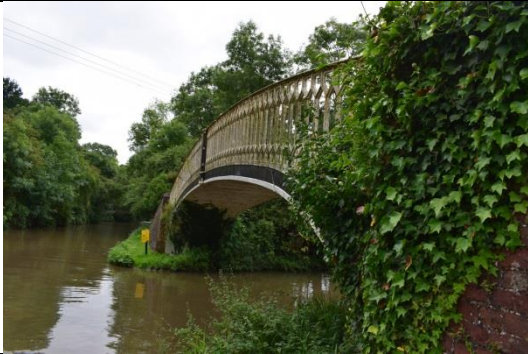
Morgans Bridge, Oxford Canal	II

- **Evidential Value:** The bridge shows the proliferation of ornate buildings and structures on the arrival of a canal to the town. Constructed of prefabricated cast iron plates and moulded railings, the bridge is a monument to the importance of the canal network and the industrial revolution to the England, as well as its demise with the closed arm in close proximity.

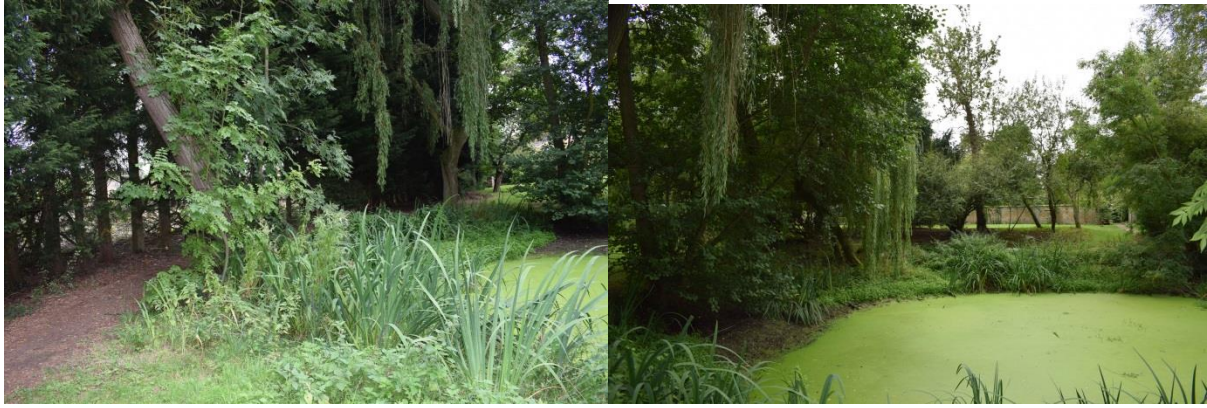
Left: Line of trees to the rear boundary of the Manor House; Right formal gardens to the rear of the Manor House.

- **The Manor House (Grade II):** The Manor house adjoins the south of the subject site, with a line of trees marking the boundary. Beyond these trees lies the grounds of the Manor House, as the subject site containing an orchard would have formed part of this site also. The harm caused as a result of the development is 'less than substantial' with the main harm caused is to the aesthetic, historic and evidential values in that the surrounding environment and the experience of the garden itself will have an increase of urbanisation, and a loss of its countryside setting, a loss of the historic relationship of the former orchard.
